iLive IKBC384S Disk Drive Replacement

Replace your faulty disk drive in your iLive IKBC384S.

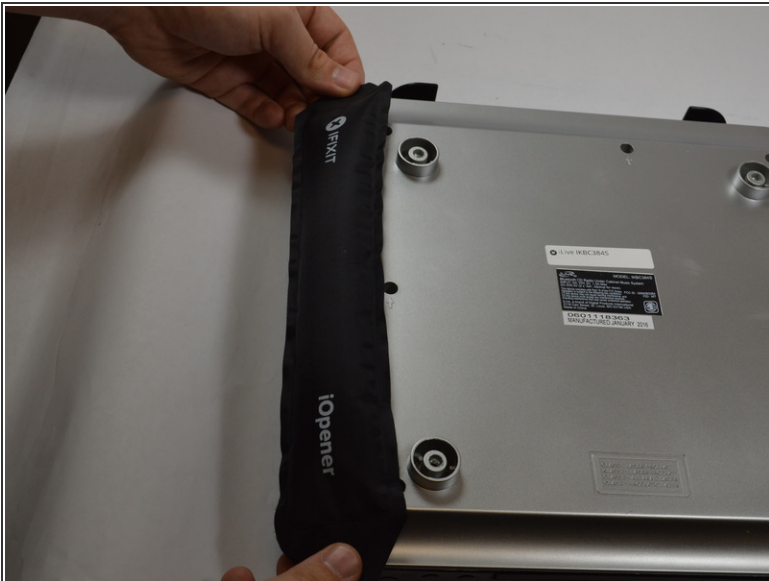
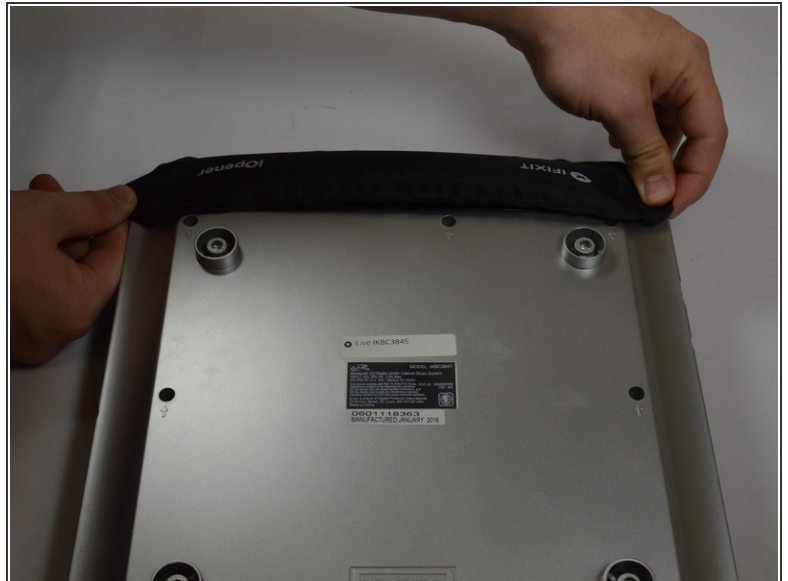
Step 2

- Use iOpener or heat gun on all sides except the front.

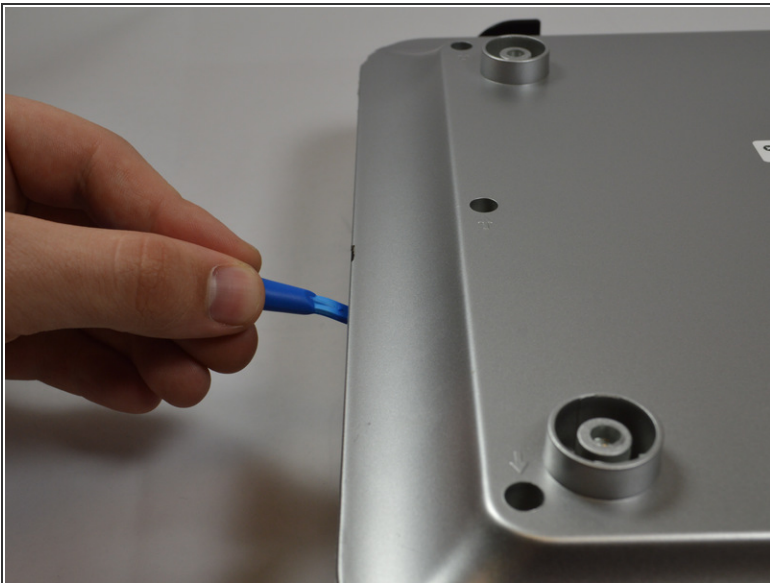
Step 3

- Be cautious when taking the top of the device off there may still be some adhesive stuck to device.

⚠ The top of the device will be very difficult to remove because of the adhesive holding it together.
